AAA Home Inspections

5904 34th Ave SW Seattle WA 98126

17:19 June 12, 2017

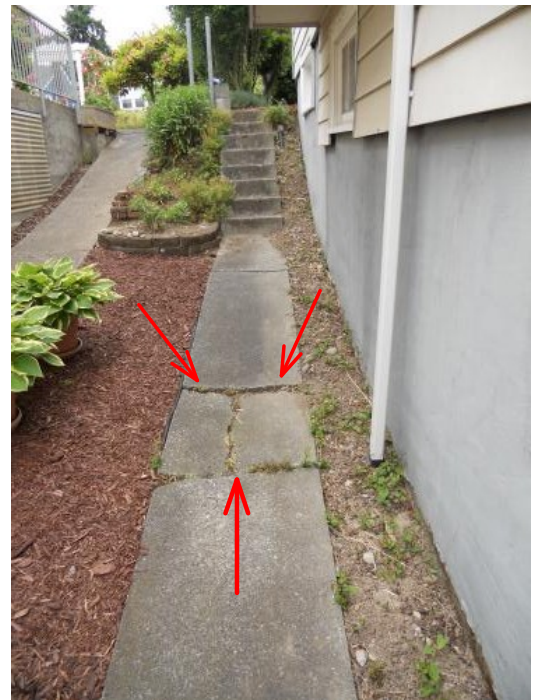
#4 Settling and trip hazard cracks in walkways.

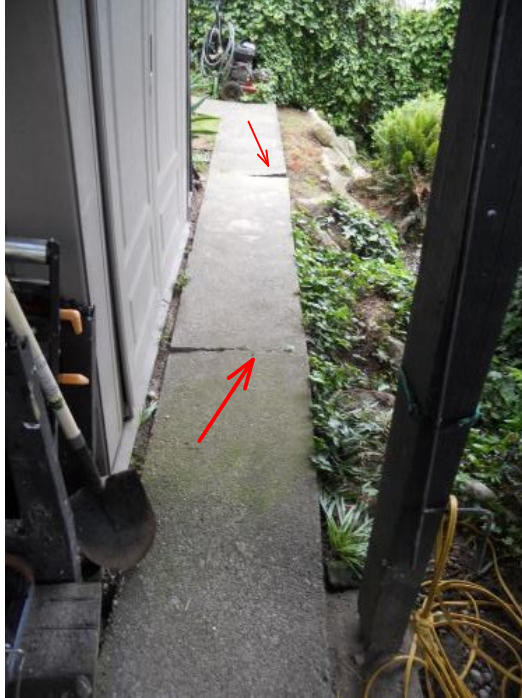
#5 Settling and trip hazard cracks in walkways.

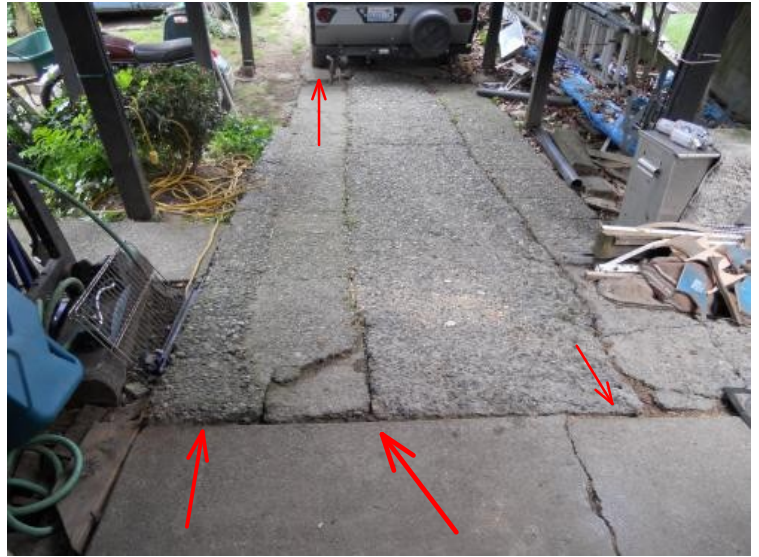
#6 Settling and trip hazard cracks in walkway/ driveaway.

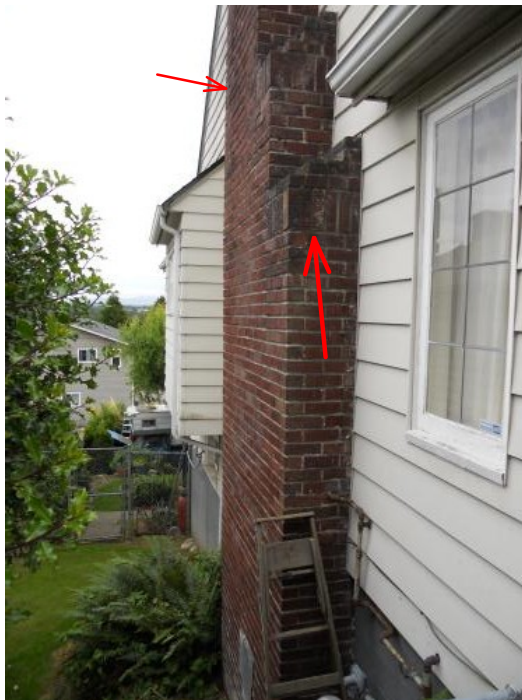
#7 Chimney in need of maintenance/ re-pointing of mortar joints.

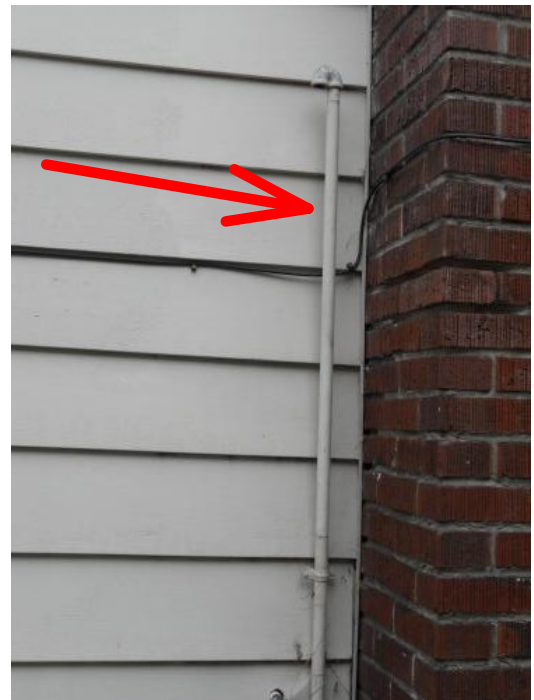
#8 Sign of underground oil tank.

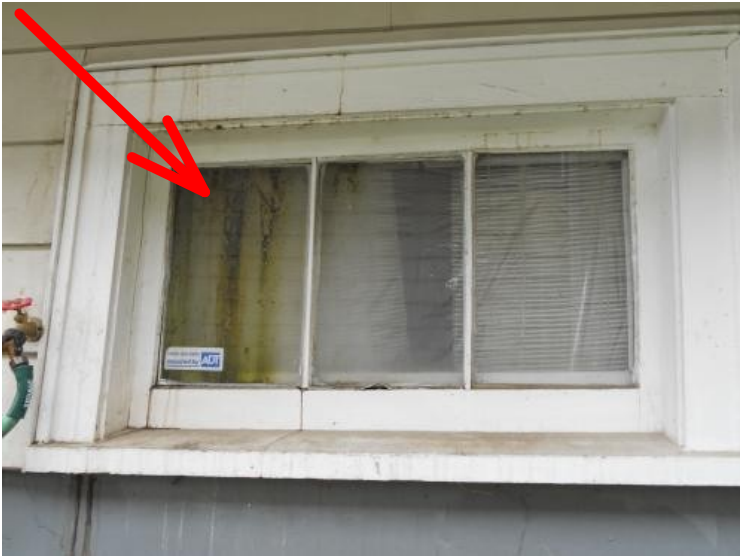
#9 Signs of leak from inside basement plumbing.

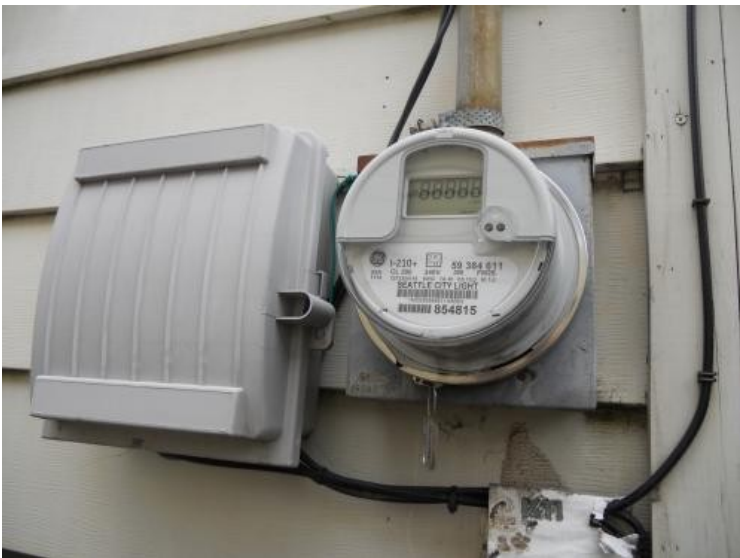
#11 125 Amp service.

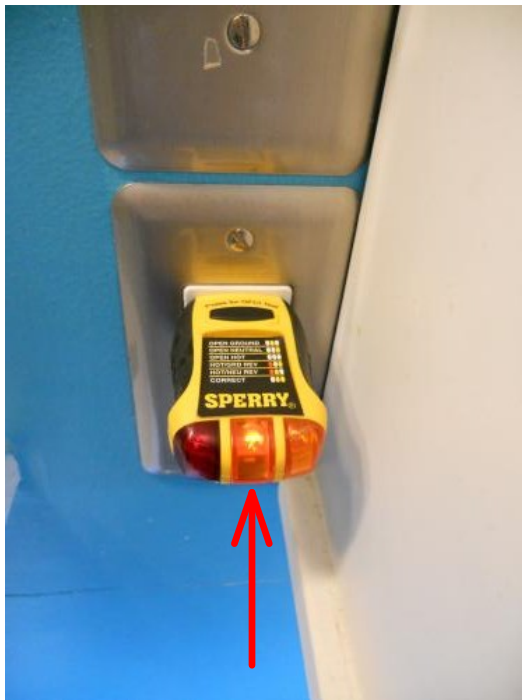
#19 Open or ungrounded connection.

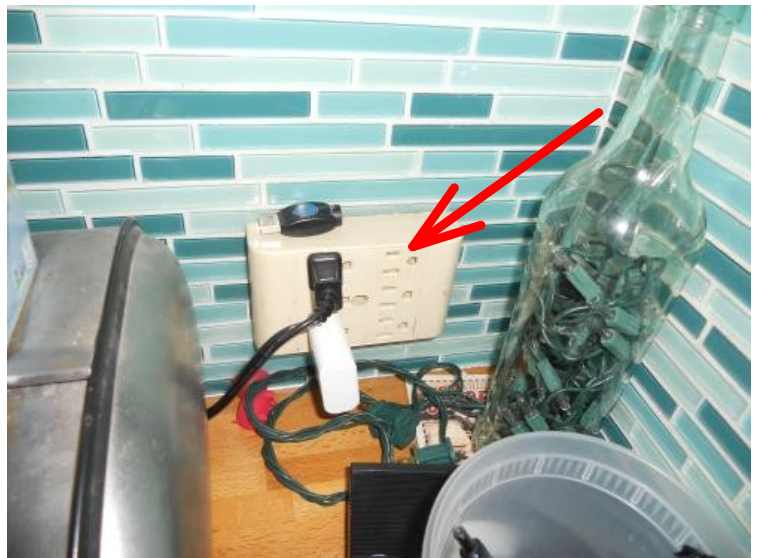
#20 Non GFCI outlet near kitchen sink.

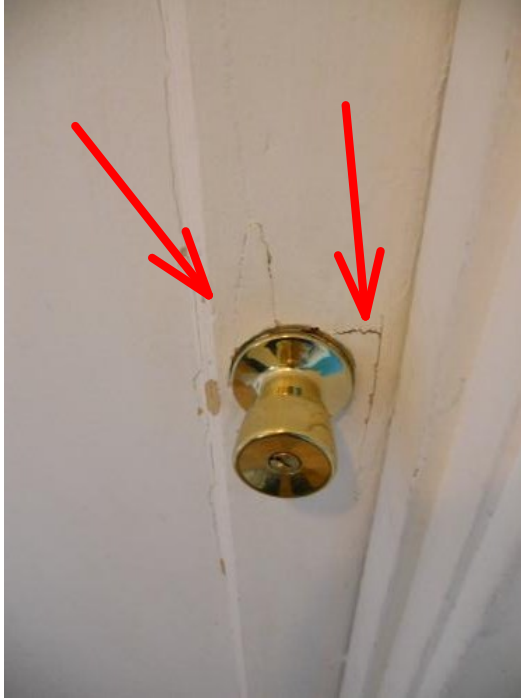
#21 Structural cracks in east bedroom door.

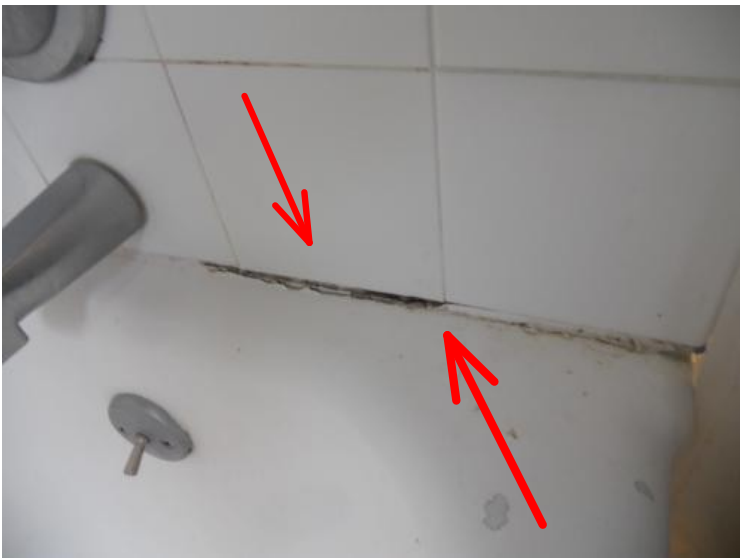
#23 Caulk needs replacement/repair in downstairs bath.

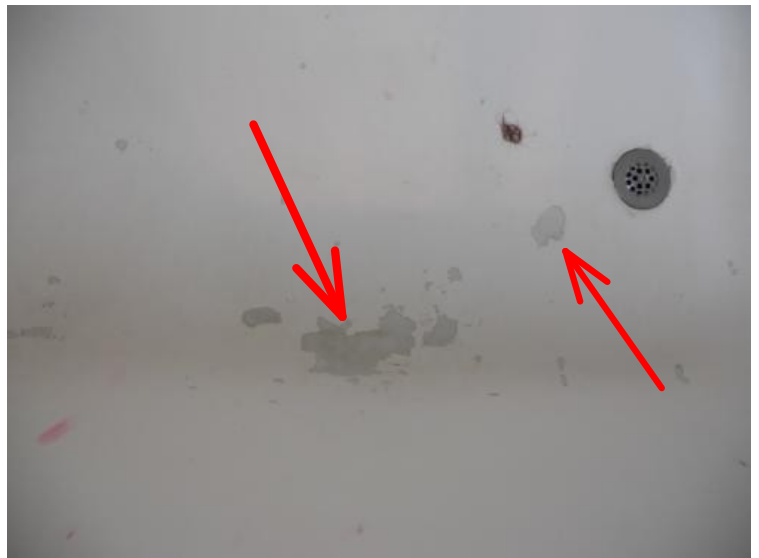
#24 Tub in downstairs bath has peeling epoxy coating.

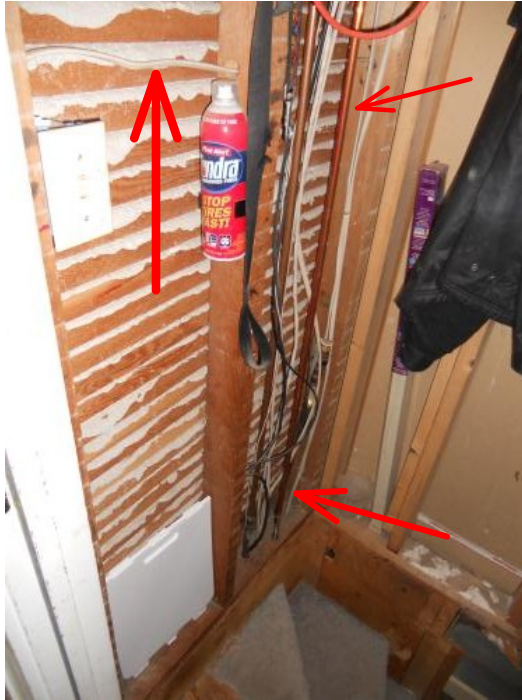
#25 Unfinished walls in basement stairwell have exposed wiring and plumbing.

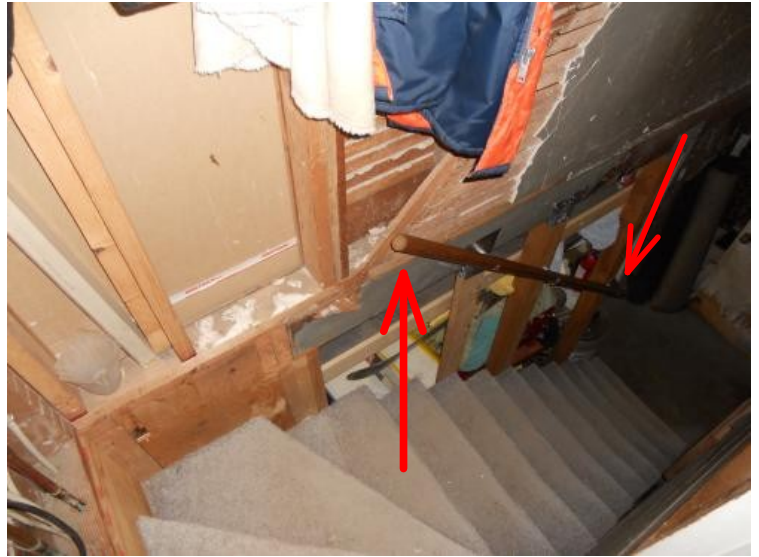
#26 Handrails do not extend entire length of stairwells.

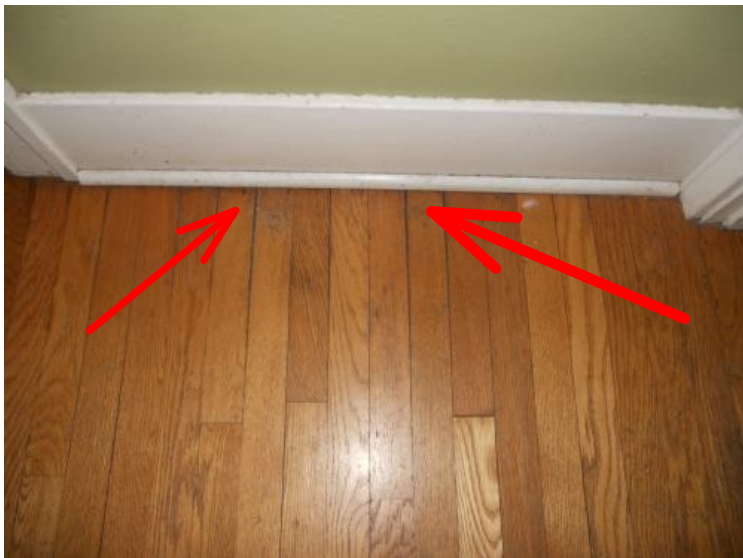
#27 Open gaps and in need of refinishing noted in main level hardwood flooring.

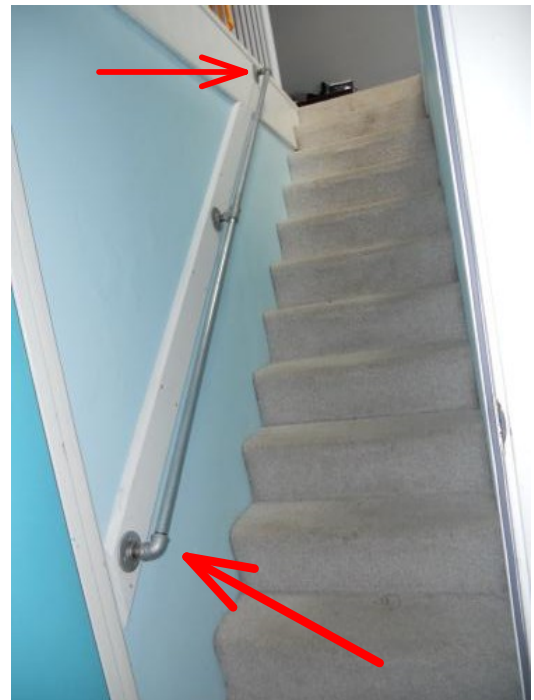
#28 Handrails do not extend entire length of stairwells.

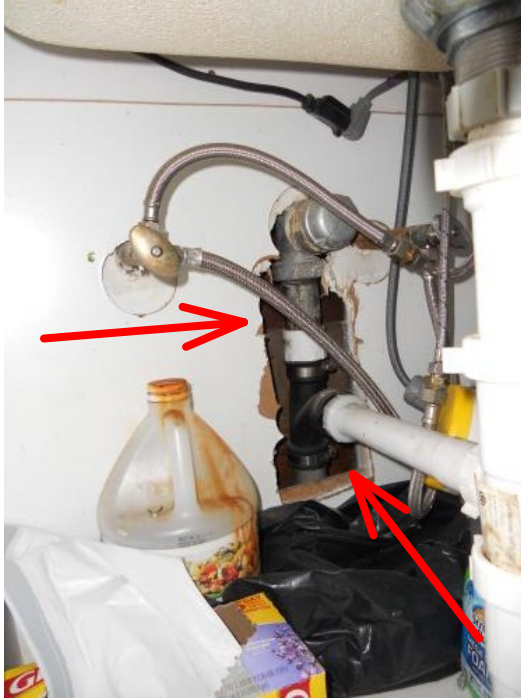
#29 Open wall where plumbing enters under kitchen sink should be sealed off.

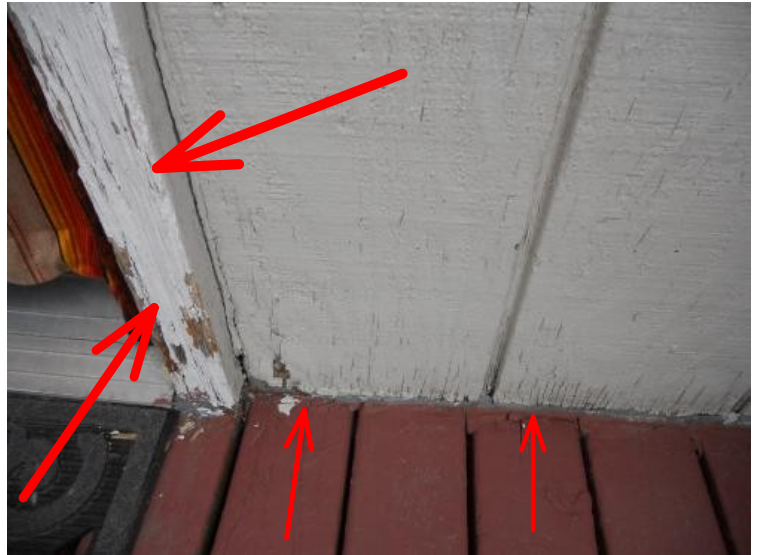
#30 Wood in need of repair at entry to deck from kitchen/dining room. Decking is not properly flashed at siding junction and in need of caulking.

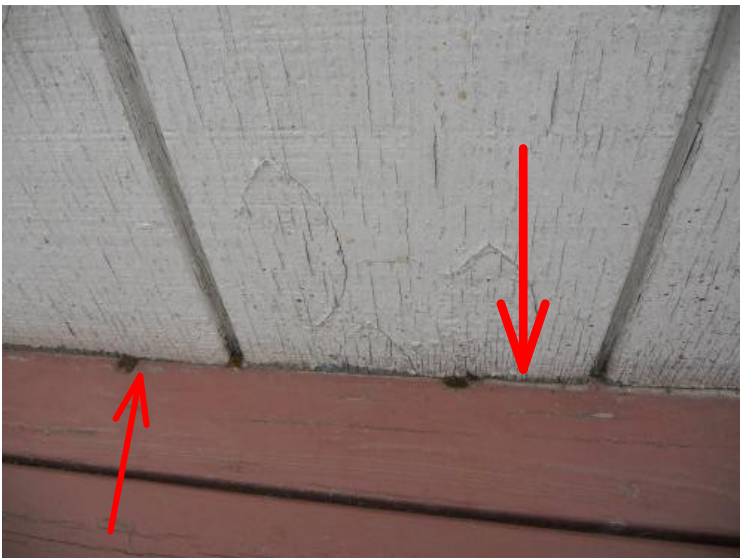
#31 Decking is not properly flashed at siding junction and in need of caulking.

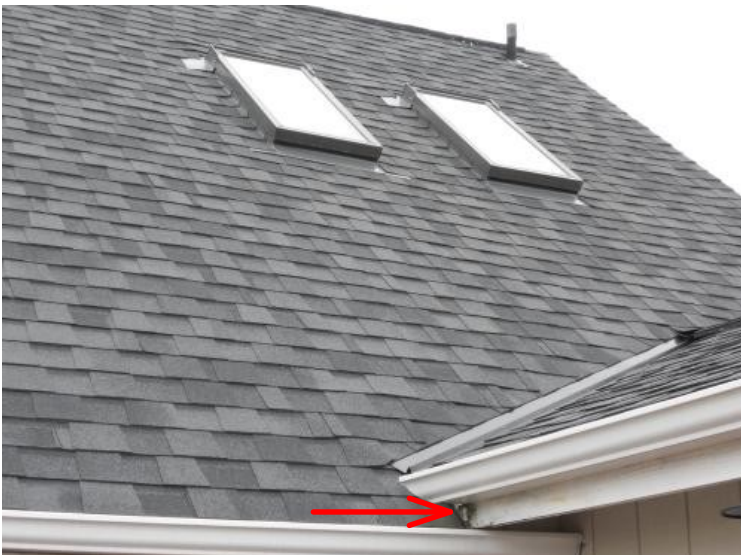
#35 Wood fascia in contact with roofing material at dining room to main house roof junction.

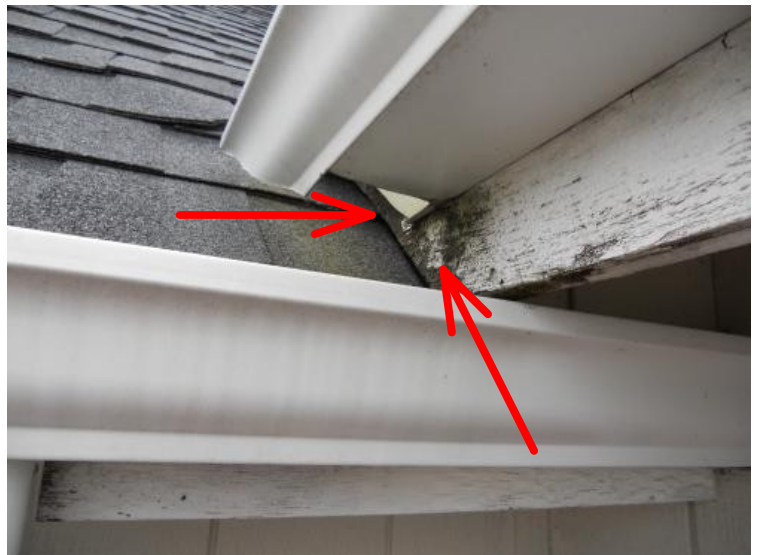
#36 Wood fascia in contact with roofing material at dining room to main house roof junction.
